Yes, Virginia, there is a converter station after all

Thanks to a massive team effort by RMR crews, the Virginia Smith Converter Station is now fully functional after a fire damaged a transformer last Memorial Day.

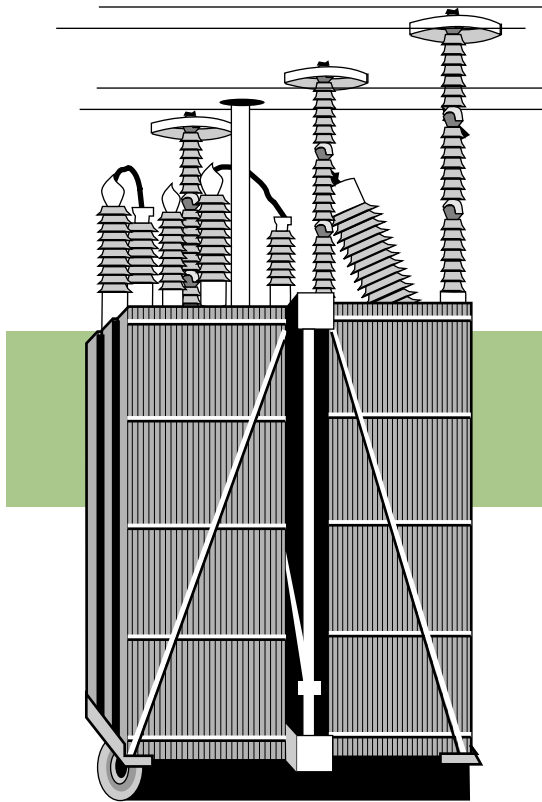
The fire started when a transformer bushing exploded. (A bushing insulates an energized conductor as it enters a piece of electrical equipment.) Oil leaking around the bushing fueled the fire until the local fire department could extinguish it.

In October, crews from Loveland and Cheyenne joined the Brush team in replacing the bushings—a massive undertaking. Replacements involved draining 9,000 gallons of oil from each trans-

former, removing and installing the bushings, refilling the tanks with oil and venting and testing, among other tasks.
